Rapid Visual Screening of RC frame buildings in 2001 Bhuj earthquake affected Rambaug area of Ahmedabad, Gujarat

ABSTRACT

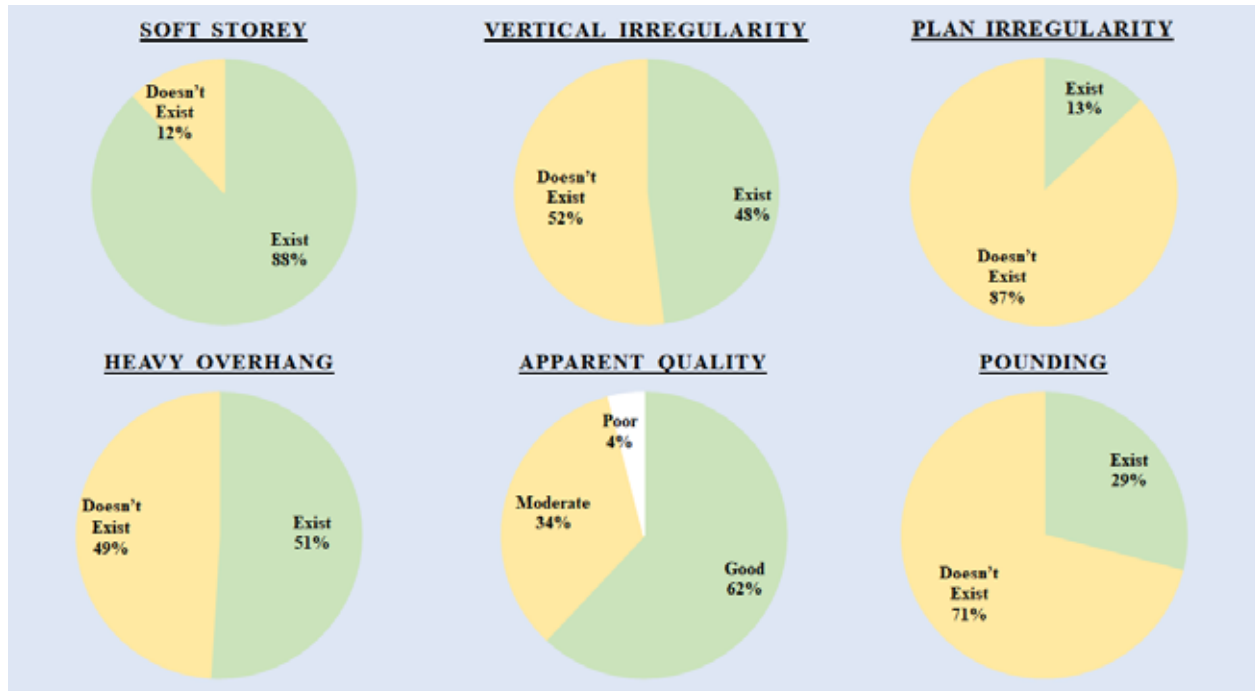
Figure 3. Distribution of various vulnerability parameters present in surveyed buildings.

The Performance score of the building depends on the base score and the vulnerability score. The Base score in the RVS form for a building depends on the seismic zone where it lies in, and the number of storeys. For 100 surveyed buildings, the number of storeys ranges from 2 to 6, which consists of 67 buildings having 5 storeys. 89 buildings out of 100 were the residential type. Figure 3 shows the distribution of the vulnerability parameters observed in buildings during the survey.

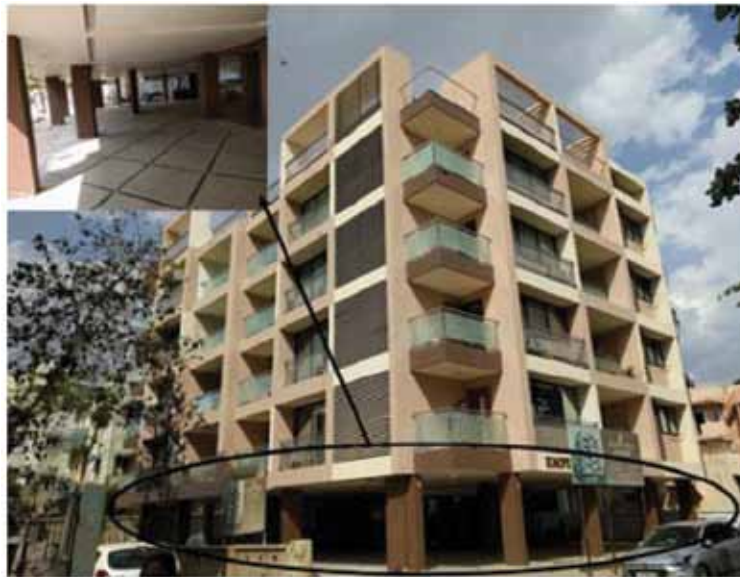
From RVS, it was observed that soft storey was present in 88 buildings, which are a significant number considering the fact that Murty et al., (2002) have reported the presence of this factor was also found in almost all of collapsed RC frame buildings of Ahmedabad during 2001 Bhuj earthquake. Figure 4 shows the presence of open ground storey which was observed in one of the flat/apartment type residential building to facilitate the vehicle parking. A surveyed building is shown in Figure 5 of G+4 storey has half of the ground storey left open which is used for the vehicle parking and another half of the ground storey used for the residence. Thus making the building partially open/soft storey. As also seen in Figure 5 the floor level of the left and the right portion of the building are not in the

Figure 4. Soft storey

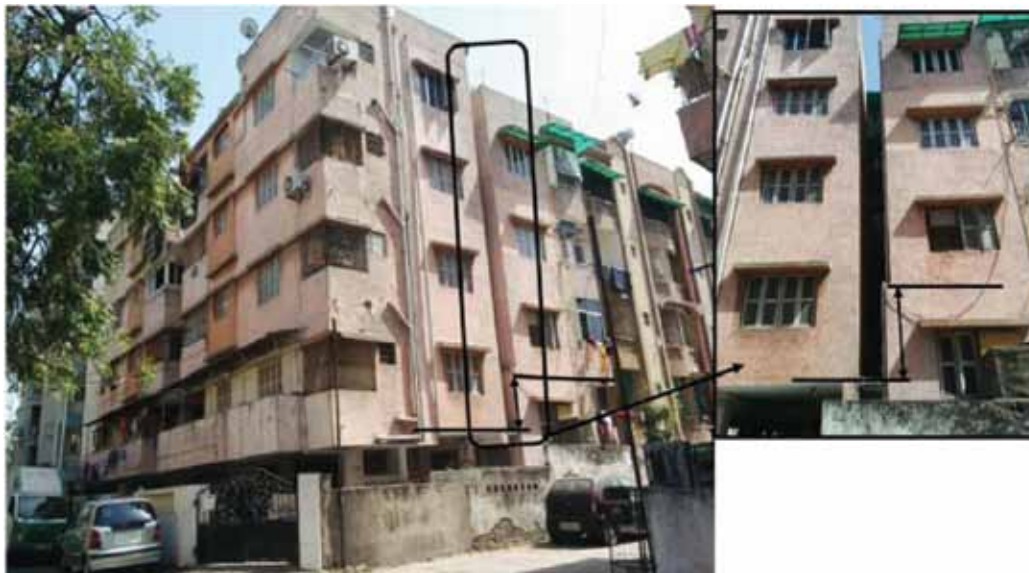
same level, therefore, several irregularities can be observed both along the height as well as in the plan.

Figure 5. Partial soft storey

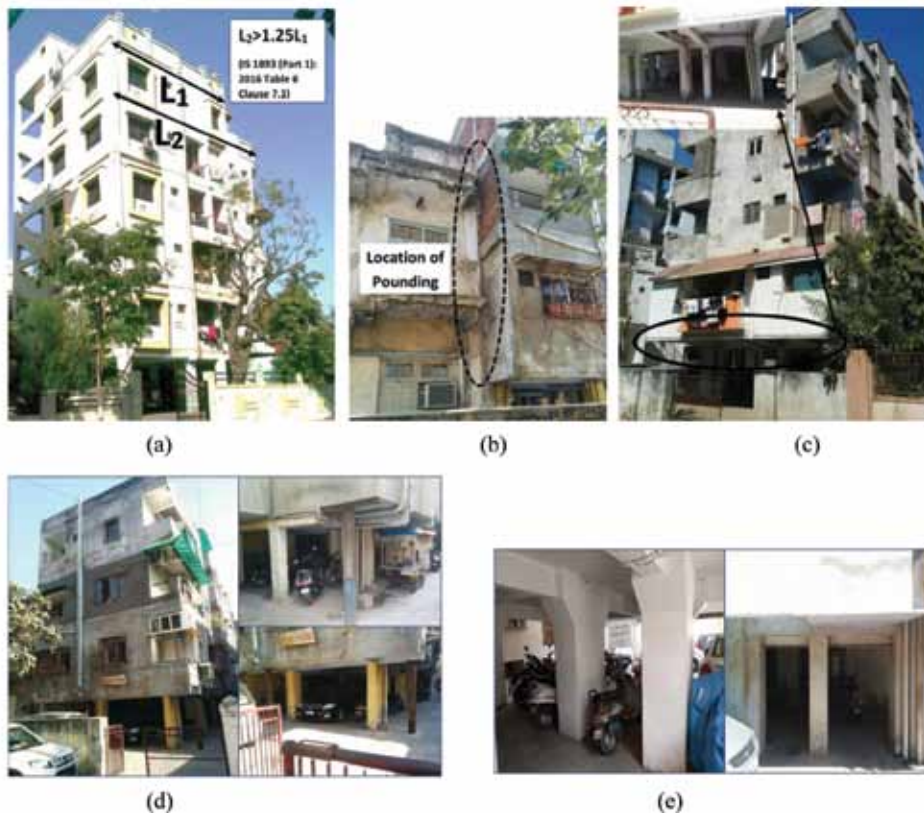
It is also reported (Murty et al., 2002) that the buildings with the poor quality of construction, horizontal irregularities (e.g., those with re-entrant corners such as L-shape plans) and those with vertical irregularities (e.g., vertical setbacks in structures), were common in the affected area. 48 surveyed buildings had vertical irregularities in the form of vertical setbacks. Figure 6(a) shows the presence of setback observed in the building at the time of the survey (approximate measurements taken using the google earth). Plan irregularities observed in the surveyed buildings in the form of the re-entrant corners. The pounding effect found to be existing in the 29-screened buildings. Figure 6(b) shows the location of pounding seen in a building, where the roof of the shorter building may pound at the mid-height of the columns in the taller building, which might be dangerous and can lead to storey collapse. Overhang found to exist in 51 buildings. Figure 6(c) shows the presence of overhang. Its presence will not lead to the collapse of the buildings but it might contribute to the building damage. Buildings also observed with the issue of poor quality of construction and maintenance, which may require moderate repairs. Figure 6(d) shows the building with poor construction quality. Presence of these vulnerability parameters can affect the performance of the buildings in an event of an earthquake if not properly designed for. Some surveyed buildings had suffered heavy damages in the 2001 earthquake. The carried out retrofitting works such as jacketing of column

and beam, wall thickening and adding of infill walls (RC/Brick filling) were observed in the survey. Figure 6(e) shows the retrofitting work column jacketing observed in a screened building.

Figure 6. ((a) Vertical setback, (b) Possible location of occurrence of Pounding, (c) Overhang in form of jutting out balconies, (d) Poor quality of construction (e) Retrofitting through Column jacketing and steel I beam).

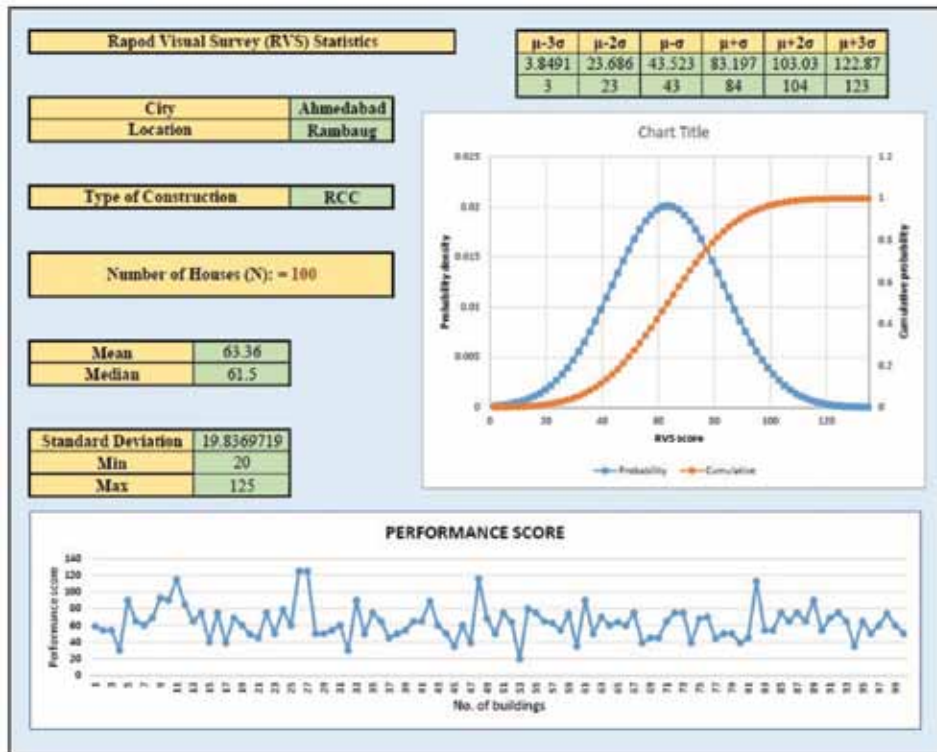
Based on the performance scores and Gaussian Normal distribution, a conclusion can be drawn that higher the performance score lesser the vulnerability of the building to earthquake when compared to buildings having the low-performance score. Figure 7 shows the Gaussian distribution of the obtained scores for the surveyed buildings. The performance scores for the surveyed RC frame buildings in the study area are predominantly ranging from 20 to 125. The buildings in the middle range (43-

84) of performance score are large in number. However, there are some low-performance score buildings, which are potentially vulnerable to future earthquakes. The total number of buildings surveyed are 100 with mean and the standard deviation scores as 63.41 and 61.5 respectively. Hence, these scores are helpful in selecting buildings with a higher vulnerability for detailed evaluation. Building Vulnerability map is shown in Figure 8, it represents the building state based on the obtained RVS scores and applied statistical method. Here the building damage states like no damage, slight damage, moderate damage, severe damage, and collapse state are classified based on the $\mu-3\sigma$, $\mu-2\sigma$, $\mu-\sigma$, μ , $\mu+\sigma$, $\mu+2\sigma$, and $\mu+3\sigma$.

Figure 7. Gaussian distribution for surveyed buildings.
